## M8 FERMOY BYPASS BRIDGE, IRELAND - TF EXPANSION JOINT REPLACEMENT

Replacement of expansion joint - supply and installation of 1 no. 23m Ekspan TF 1300 expansion joint.

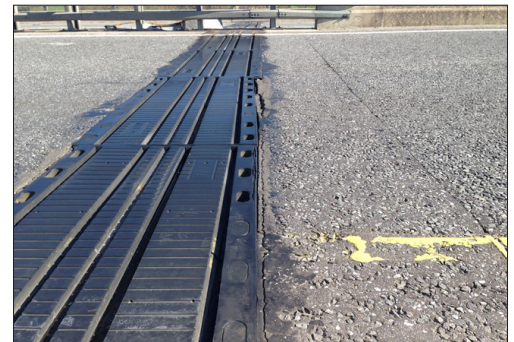
USL Ekspan's inspection had also verified the failing of the south abutment expansion joints and their incapability to achieve the designed bridge movements or accommodate the bridge expansion gap between the deck and abutment ballast wall. This inadequacy had forced the joint fixings to rotate and shear due to the bridge's large thermal movements and the loads/speeds of vehicles travelling across. The joint was audible and sporadic bouncing was visible during transit. Eventually this would result in the joint lifting out of the road, creating a catastrophic hazard to motorists, especially motorbikes. The north abutment joints had deteriorated, not to the same extent, but also required maintenance as these too were likely to fail in the same way.

*Failed expansion joint - showing detachment from surface, delamination and joint exposure.*

USL Ekspan's programme of works was undertaken in three phases. These included removal of the south abutment joints; installation of the secondary seal and downpipes to suit the existing drainage arrangement and installation of one 23 m TF 1300 over both carriageways. Remedial works were carried out on the north abutment joints.

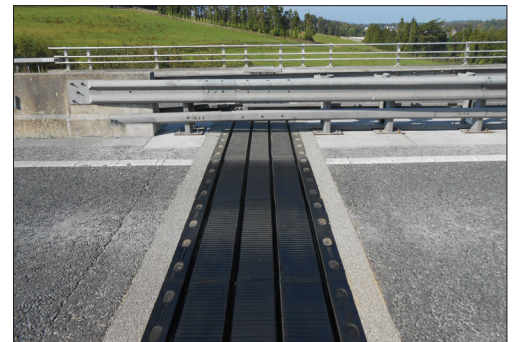
*New installed TF1300 expansion joint*

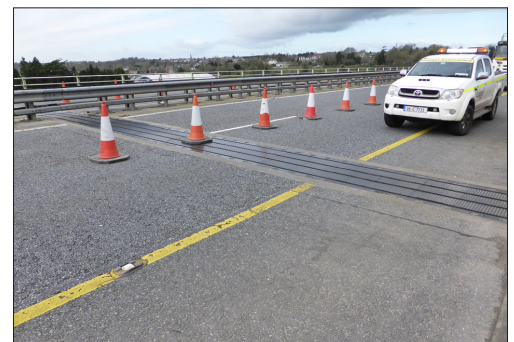
*Completion of replaced expansion joint*
