# Hydro-Electric Power Station – Low Head High Pressure Pipeline – Pipe Section Replacement

## JOB BRIEF

- Supplied: Manufacture and installation of 1 no new pipe section
- Project Team
- Client: NPower Renewables Ltd.
- Main Contractor: EKSPAN
- Start Date: September 2011
- Completion Date: October 2011

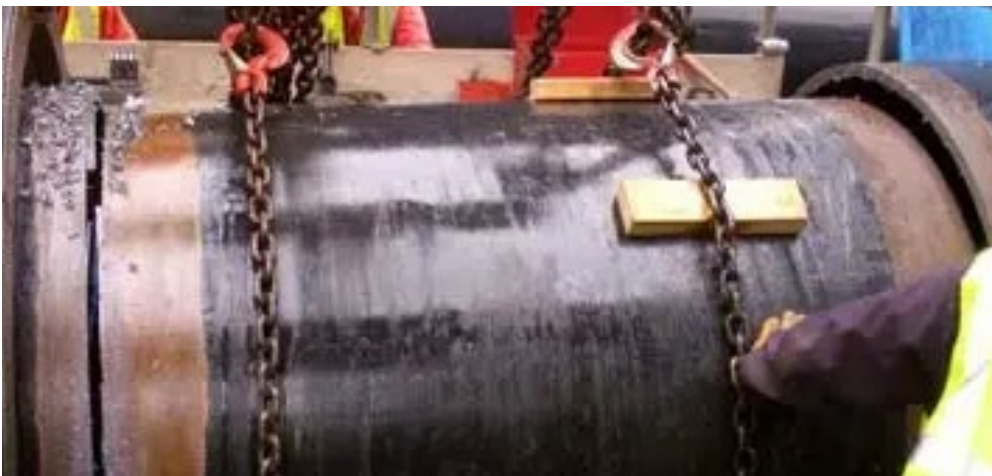
A previous temporary emergency repair had been carried out to a damaged section of the pipeline using carbon wrap, the wall thickness of this pipe section had started to erode and showed signs of water leaking through, this section required removal and replacement. EKSPAN, having already carried out previous pipeline refurbishment work, were selected by NPower Renewables to carry out all necessary works to resolve this problem.

Temporary saddles were positioned beneath the pipe and on top of specifically designed and built concrete bases to support the pipe during the works. These temporary supports were monitored throughout the works process for displacement. The existing foundations were then dug and removed to allow installation of the new pipe section. The old pipe was removed using a lathe to accurately machine cut.

A new section was fabricated complete with support bracket. The old section was machined to accept a Viking Johnson joint. The 2 (1 old, 1 new) pipe sections were welded (new) and bolted (old) in position. Once installation was complete the pipe section was painted and the surface areas prepared where the new pipe and saddle had been welded together.
