# Case Study - Bearings & Bridge Jacking

## WESTERN BANK UNDERPASS BRIDGE - BEARING INSTALLATION & BRIDGE REFURBISHMENT

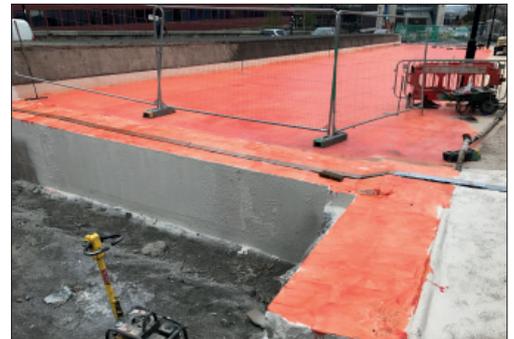
Water proofing applied to the bridge deck

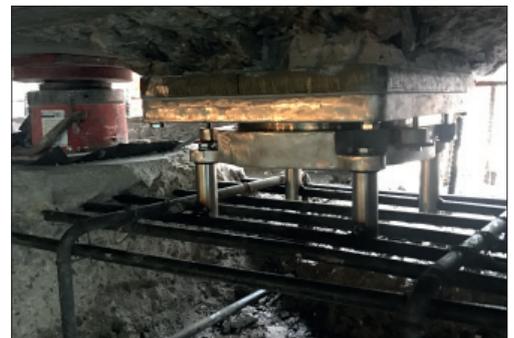
Temporary jacks, hydro demolition and bearing installation

Site works on the bridge's north and south abutments included; site set-up and marking up for hydro demolition works; breaking out the concrete bearing shelf; installation of jacking equipment and bridge jacking; bearing removal and installation of 8 no pot bearings; replacement of waterproofing on the bridge deck; removal and replacement of expansion joints; concrete repairs to the bridge abutments, deck ends, parapet units, deck cantilevers and retaining walls.

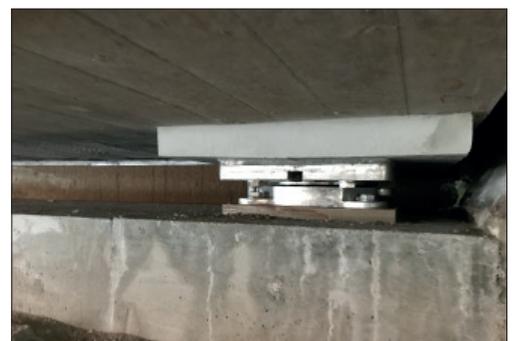
New installed pot bearing
